Ergonomics Interventions at Badger Mining Corporation

Janet Torma-Krajewski

Martin Lehman

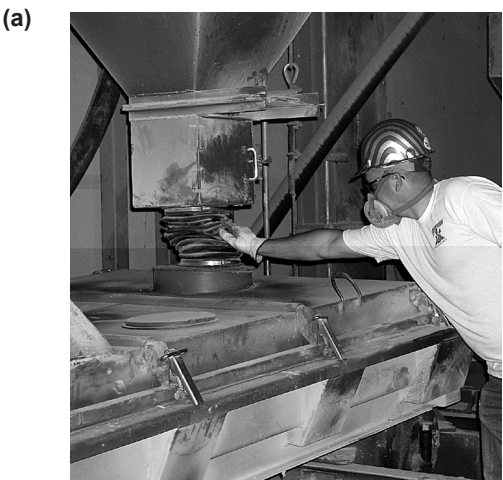
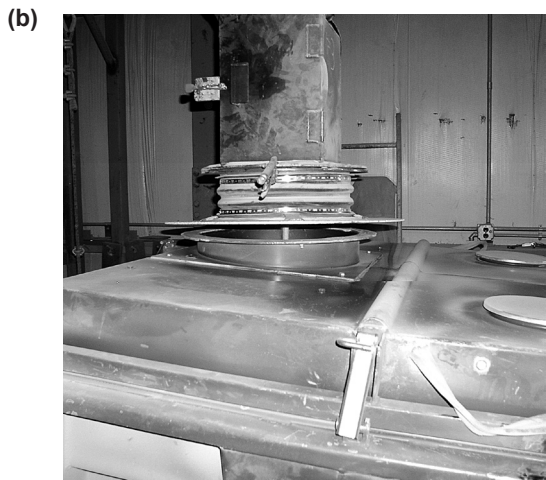
To maintain the actuator, internal orifice plates needed to be removed and replaced when they became clogged with wet sand (Figure 5a).

Completing this task once a shift resulted in exposure to awkward postures (excessive reaching and leaning forward) and climbing four flights of stairs.

Figure 5. (a) Manually reset actuator, (b) automatic actuator.

Installing an automatic actuator eliminated the need to manually maintain it, the awkward postures as well as climbing the stairs (Figure 5b). The automatic actuator was 500 USD plus labor.

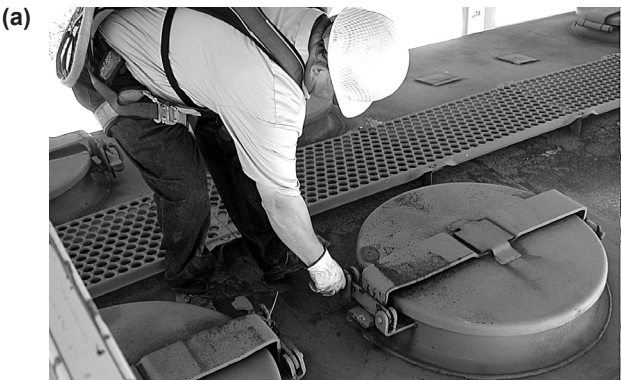
To open the rail car cover, the associate used his foot to release the latch while bending over to open the cover (Figure 6a). This task was

Figure 6. Rail cover latch released (a) manually and (b) with a hand tool.

done every day, 8 times per shift. Associates experienced hip and back discomfort.

Two hand tools were constructed by the maintenance team to unlatch different types of covers. The associate knelt on one knee as he placed the tool on the latch and then pushed down on the tool with his arm to release the latch. Once the latch was released, the cover was opened (Figure 6b). Although the associate was still exposed to an awkward posture, briefly kneeling on one knee probably resulted in less risk than the trunk flexion when the hand tool was not used. The material used to fabricate the two tools was available scrap material so the only cost associated with this intervention was for labor.
